# TEST REPORT RAPPORTO DI PROVA

## Frontal impact on model TI-VAN Prova di urto frontale su allestimento TI-VAN

Test report n.: MEC15070.00\_TR  
Revision: 00  
Document name: MEC15070.00\_TR.doc

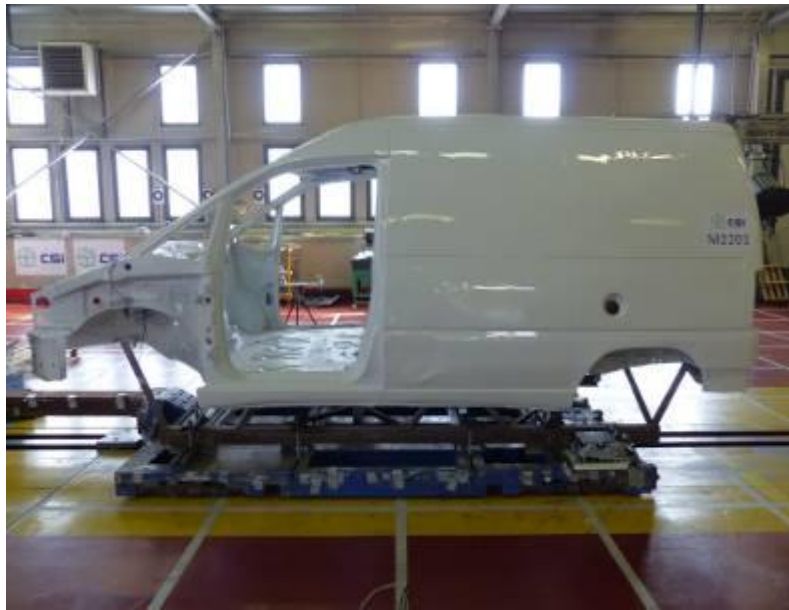
FIAT SCUDO vehicle body

Components series TI-VAN installed in FIAT SCUDO vehicle body

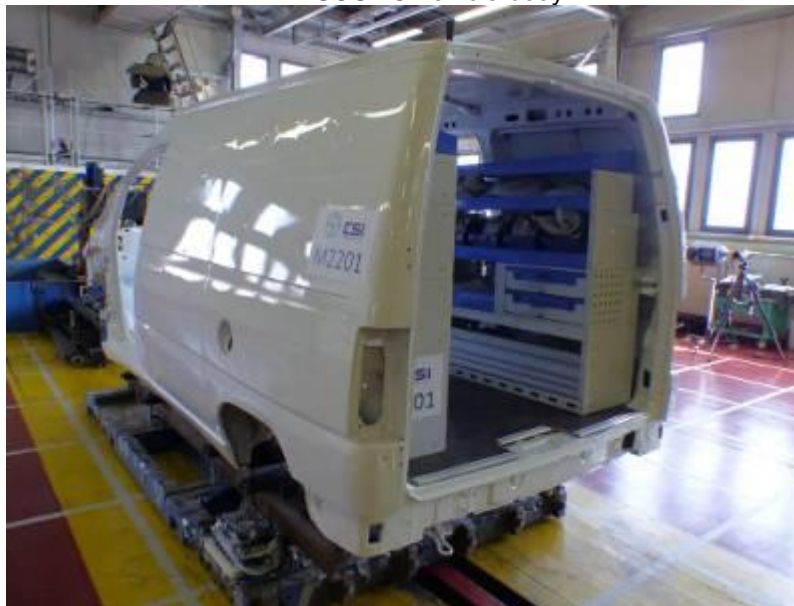
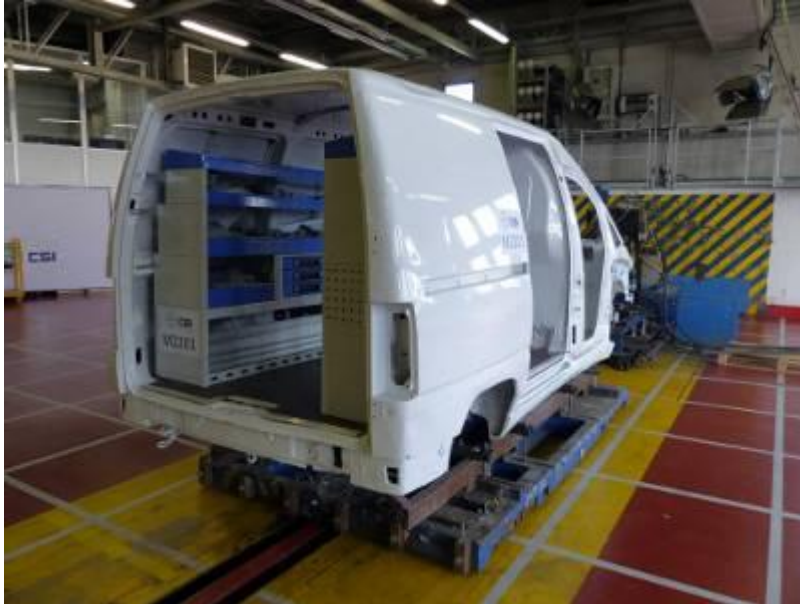
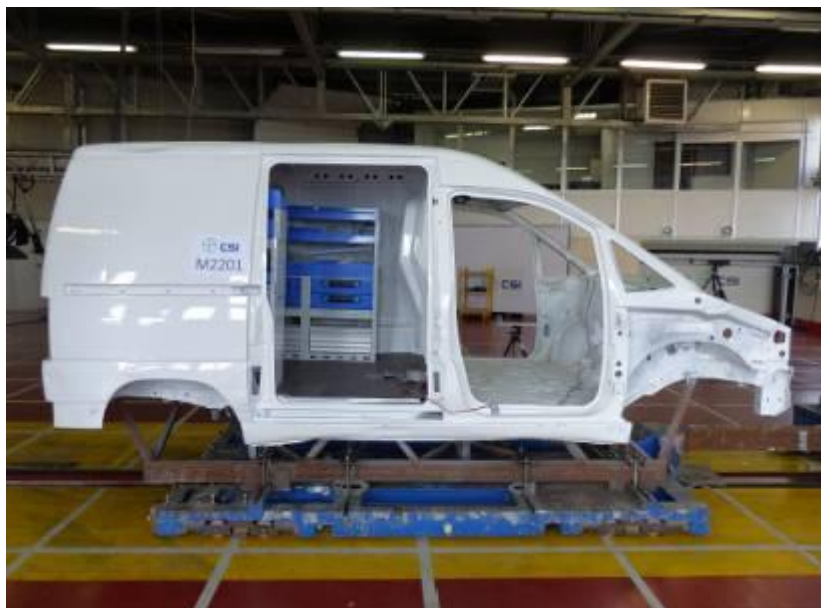
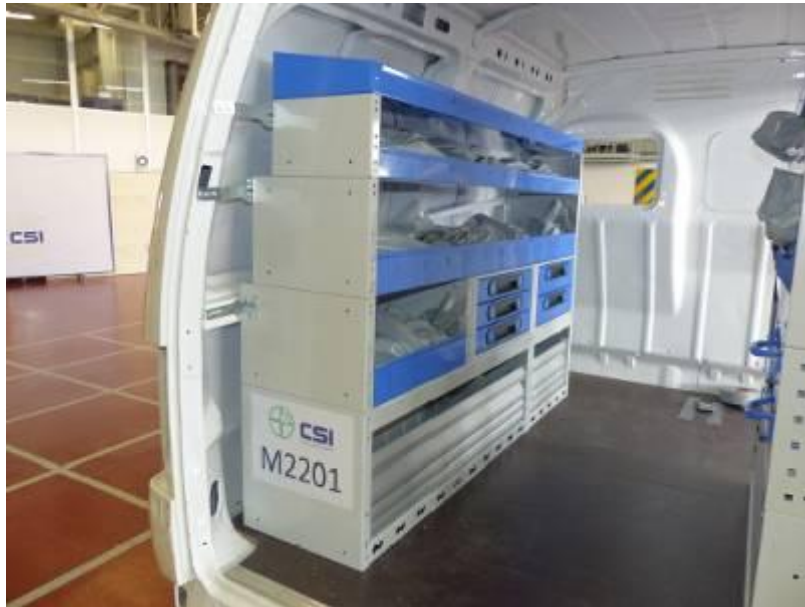
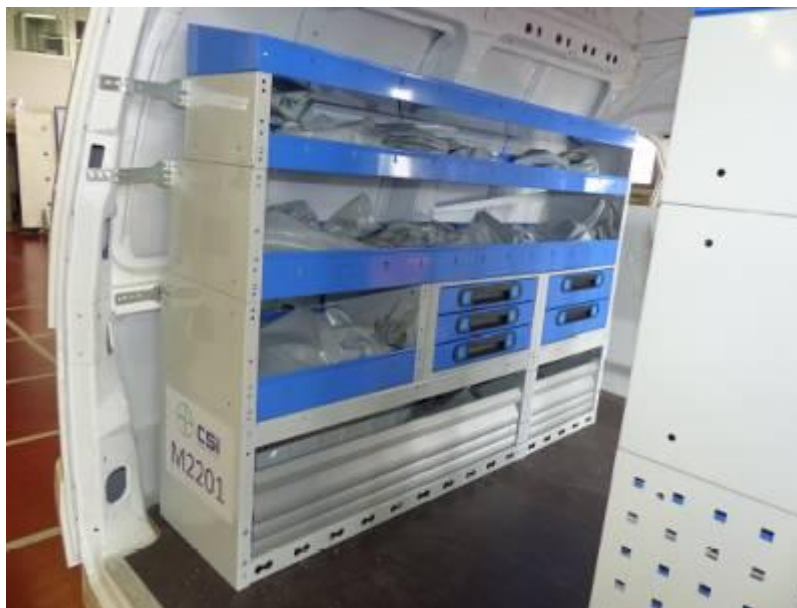
TI-VAN before the test

The FIAT SCUDO vehicle body, equipped with components for commercial vehicles TI-VAN, has been subjected to the same deceleration prescribed by regulation ECE R17 and directive 74/408/CE for the frontal impact

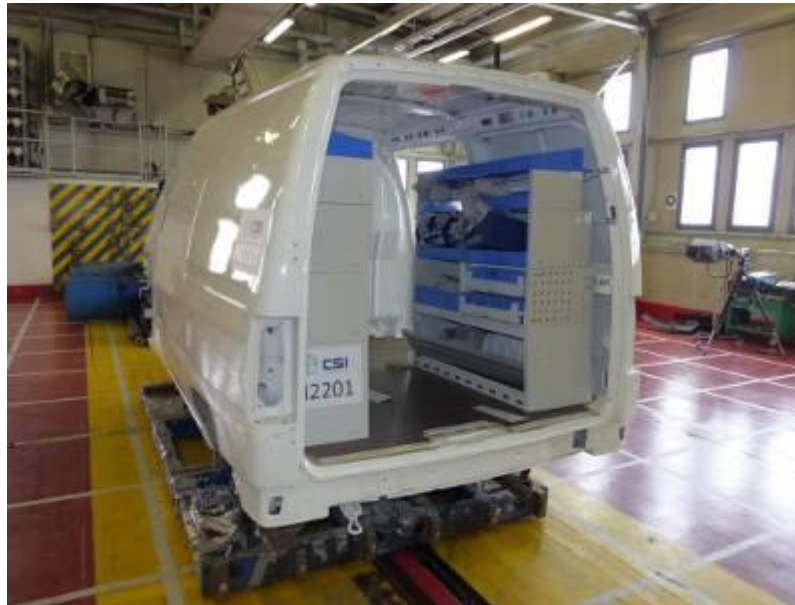
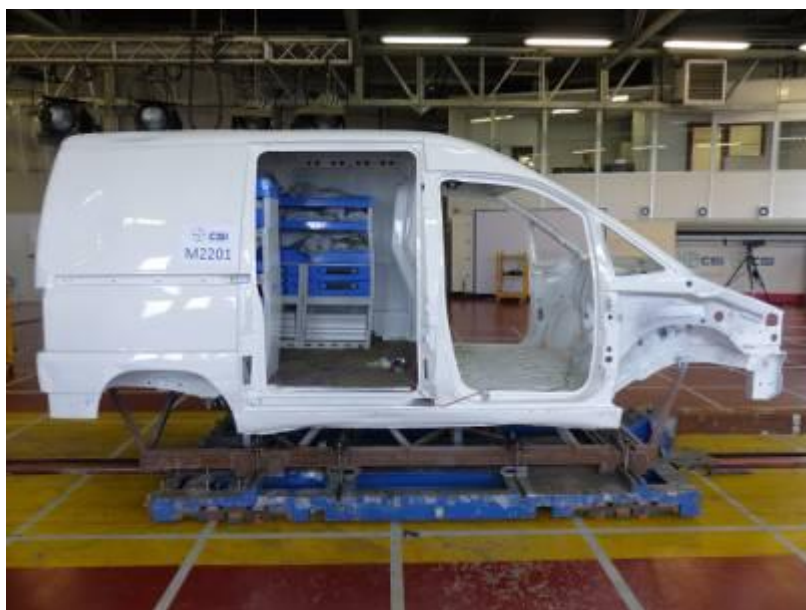
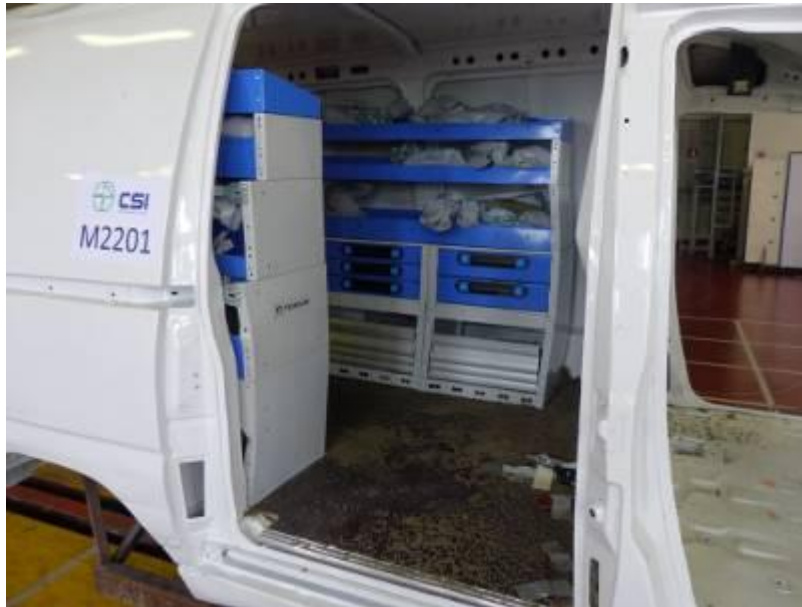
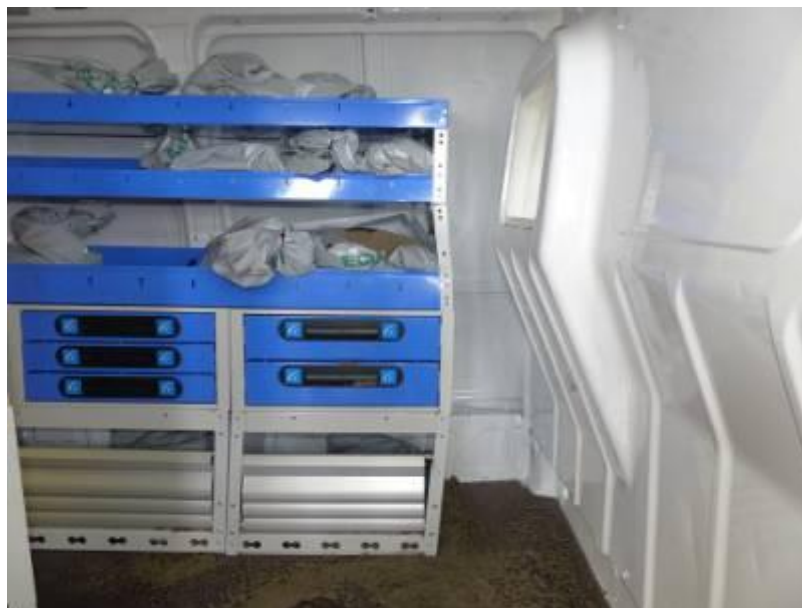
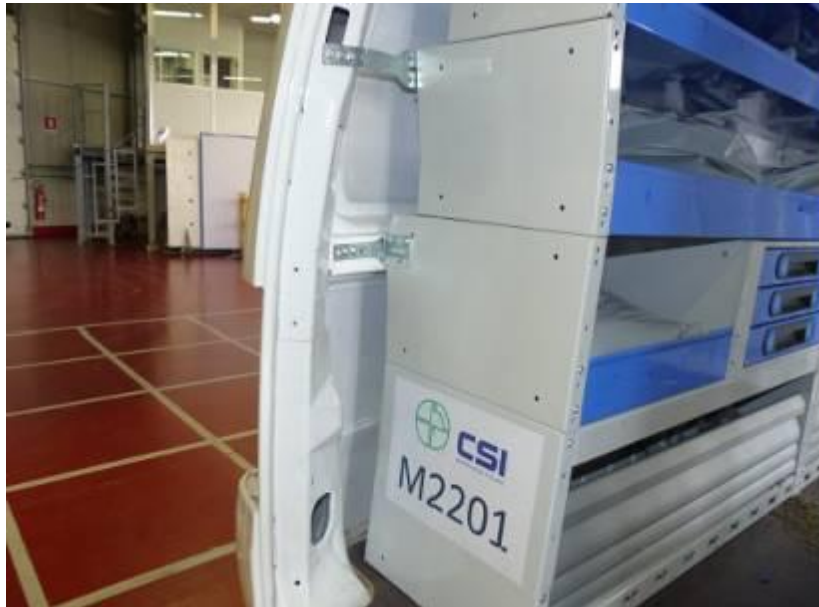
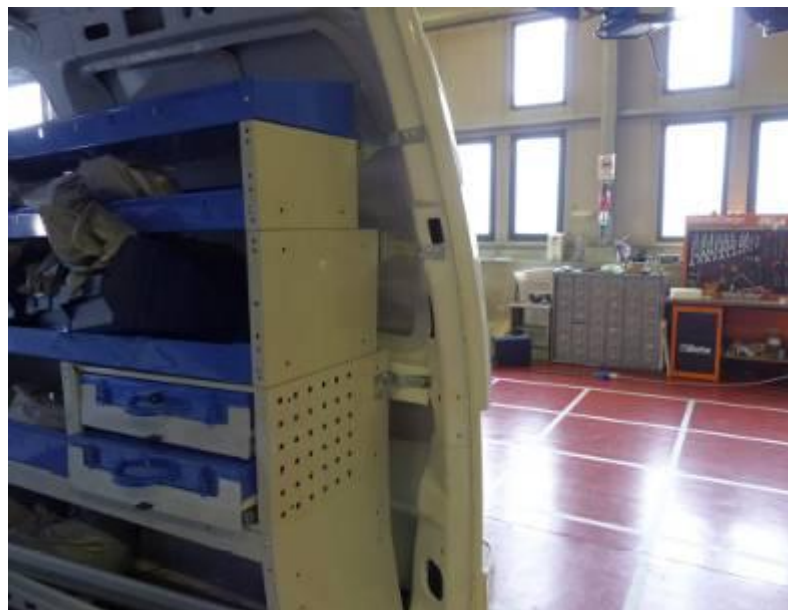
TI-VAN after the test

The requirement 20 g / 30 ms is met

- no recognizable fractures of any of the safety relevant components
- no losing of attachment parts
